ACCIDENT INVESTIGATION AND PREVENTION REPORT

**A49 – PRESTON ROAD
3.05KM – 6.15KM
CHARNOCK RICHARD**

3rd March 2008

ACCIDENT INVESTIGATION AND PREVENTION REPORT
A49, PRESTON ROAD, 3.05KM – 6.15KM, CHARNOCK RICHARD

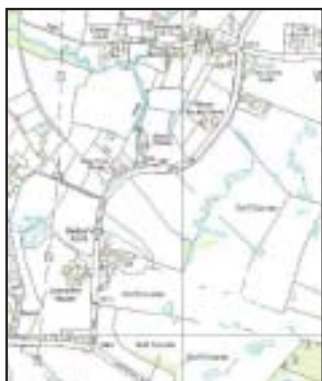
Fig 2 – Section 1 - from A49 / Mill Lane to Brook lane / Church Lane junctions.

The first section of the study length runs from the junction of the A49 with Mill Lane northerly, to the junction of Brook Lane and Church Lane. The national speed limit applies to this section of road with the exception to the section of road on the approach to the mini-roundabout at Mill Lane to which a 40mph speed limit applies. The length starts at the mini-roundabout with Mill Lane, which was put in place in 2002, the route then travels north encountering a double bend near Yew Tree Villas, which is the location of two serious accidents. Consideration should be given as to what measures could be put in place to reduce accidents on the double bend. The road continues south with a sweeping left-hand bend to the crossroads of Brook Lane and Church Lane, also the location of several

accidents. In total there have been 8 PIA's on this section of road, 3 of which have been serious with the remaining 5 being slight accidents. These resulted in a total of 11 casualties 3 of which sustained serious injuries and the remaining 8 sustained slight injuries.

- The mini-roundabout at Mill Lane.
- The double bends adjacent to Yew Tree Villas.
- The Brook Lane / Church Lane crossroads.

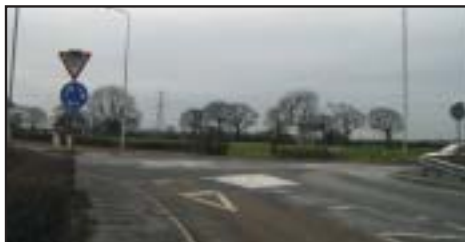
Fig 3 – Mini roundabout at Mill Lane on approach from the north.

There have been no reported injury accidents at the Mill Lane mini-roundabout. However, within the scope of this study and with a view to maintaining the current safety record some junction and signing improvements have been proposed.

- 1.1 The existing bar markings are worn and faded. Renew existing bar marking to the south of the junction.

- 1.2 The existing white lining and markings on and around the roundabout are worn. Renew the existing white lining at the junction, in particular the give way markings and mini-roundabout markings. This will improve the conspicuity of the mini-roundabout for drivers.
- 1.3 The mini-roundabout sign on the approach to the roundabout from the north is hard to distinguish from other street furniture. Re-site the existing pedestrian and cycle route sign (see fig 4) to improve visibility.

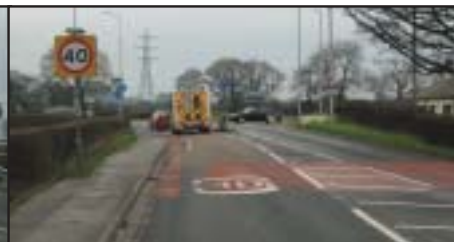
Fig 4 – Pedestrian / Cycle route sign obscuring roundabout signing.

The existing 40mph gateway (see fig 4) is becoming worn and as a result its impact is reduced.

- 1.4 Renew the existing red 'textureflex' type surfacing and 40mph carriageway roundel.

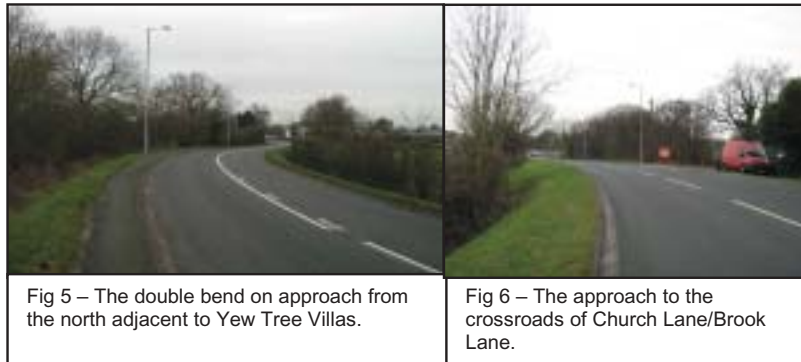
The bends in the road adjacent to Yew Tree Villas currently have no warning signs to alert motorists to their presence.

The crossroads of Brook Lane and Church Lane with the A49 (See fig 6) are the location of several accidents, two of which are specifically related to the junction. The junctions are hard to distinguish from a distance and are approach from both the north and south from around a bend.

- 1.5 Provide an illuminated double bend warning sign on approach to the bend from the south with an additional 'SLOW' carriageway marking adjacent to the sign.
- 1.6 Provide single chevrons on the right hand bend adjacent to Yew Tree Villas for vehicles approaching from both directions.
- 1.7 Provide single chevrons on the left hand bend adjacent to March House, for vehicles approaching from both directions.
- 1.8 Provide a double bend warning sign on the approach to the bend from the north with an additional 'SLOW' carriageway marking adjacent to the sign.

- 1.9 Provide a new crossroads sign and mount on grey backing board with the existing bend in road sign mounted below for traffic approaching from the south.

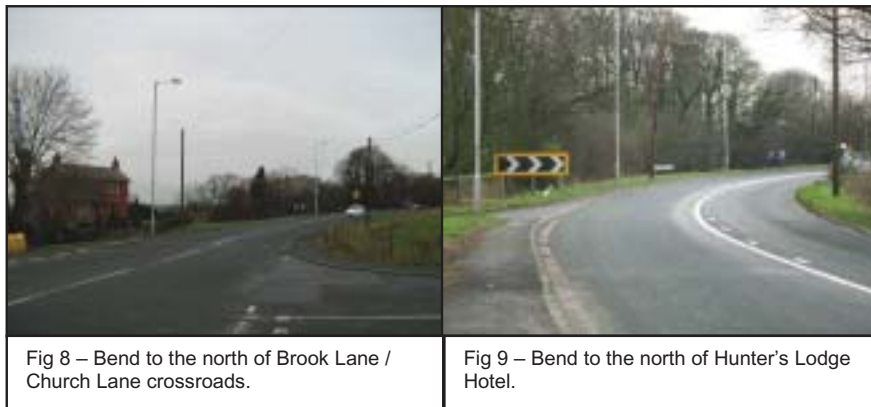
The bend to the north of the Brook Lane / Church Lane crossroads currently has a double chevron sign positioned to warn drivers travelling from the south of the road layout.

The crossroad junction is not clearly visible on approach from the north due to the road layout.

The bend adjacent to Hunter's Lodge Hotel is the location of several accidents. This is due to the road layout and the location of the hotel's access on this bend. Therefore, measures to improve driver awareness of the road layout and to inform them of the possibility of encountering emerging traffic should be considered.

The double bend adjacent to the Old Hall Lane and Delph Lane side roads is the location of three accidents, all of which are the result of vehicle failing to negotiate the bends. There are currently no warning signs to alert drivers of the road layout for vehicles travelling from the south. To the north of the double bends there is an existing double bend sign with a supplementary “for a distance of 2 miles” plate below. The sign although providing some warning to drivers does not specifically highlight the upcoming double bend.

- 2.1 For continuity of the scheme the existing double chevron sign should be replaced with single chevrons with yellow edging.

- 2.2 Provide a new crossroads warning sign and additional "SLOW" carriageway markings adjacent to the sign.

- 2.3 Provide a new other danger ahead sign with supplementary "Turning Vehicles" sign on grey backing board with "SLOW" carriageway markings adjacent to the sign on approach to the hotel entrance from the south.
- 2.4 Remove existing double chevron signs and replace with two sets of three dual-sided single chevrons signs with yellow edges to alert drivers to the road layout when travelling from both the north and south.
- 2.5 Contact the Hunter's Lodge Hotel and request that existing signing located near the carpark entrance be relocated in order to improve sightlines for drivers exiting the carpark.

- 2.6 Provide a new other danger ahead sign with supplementary “Turning Vehicles” sign on grey backing board with “SLOW” carriageway markings adjacent to the sign on approach to the hotel entrance from the north.
- 2.7 Relocated the existing bend in road sign with supplementary “Reduce Speed Now” plate and place further from the junction for vehicles travelling from the north.

- 2.8 Provide a double bend warning sign with additional “SLOW” carriageway markings adjacent to the sign for vehicles approaching from the south.
- 2.9 Provide marker posts on the western side of the carriageway adjacent to the Bowling Green public house to better delineate the bend.
- 2.10 Provide marker posts on the eastern side of the carriageway adjacent to Tan House Farm to better delineate the bend.
- 2.11 Remove the existing “for 2 miles” supplementary plate from the post with the existing double bend sign on. Additional “SLOW” carriageway markings to be placed adjacent to the sign.

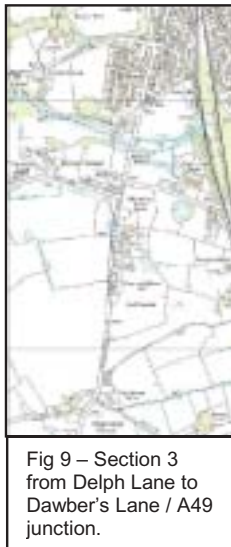
Fig 9 – Section 3 from Delph Lane to Dawber's Lane / A49 junction.

The final section of the study runs in a northerly direction from Delph Lane to the Dawber's Lane junction with the A49. This section of road is national speed limit from Delph Lane to a point near Pincock Bridge at which point the speed limit changes to 30mph for the remainder of the length. There are a few residential and commercial frontages along this section of the route as well as a new crematorium, on the approach to the mini roundabout at Dawber's Lane the frontages are residential and commercial. The newly built crematorium brings cortèges of vehicles to the study length disrupting the normal traffic flows, however this does not appear to cause a significant problem at this time.

There have been a total of 7 accidents along this section of the road resulting in 14 casualties all sustaining slight injuries.

- The existing 30mph gateway.
- The mini-roundabout at Dawber's Lane.

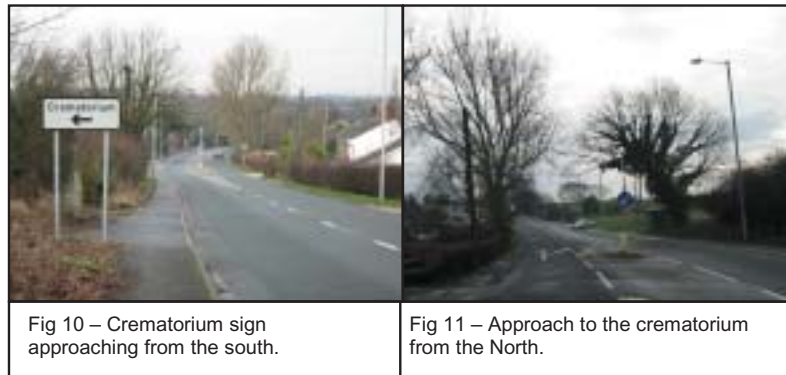
3.1 The speed limit on the length of road on the approach to the crematorium is, at present, set at the national speed limit. Due to the new access to the crematorium we would suggest that the current speed limit be reduced to 40mph.

The signing at the crematorium could be changed in order to provide a clearer message to visitors. The advanced warning sign for the crematorium from the south is misleading to some drivers who slow down to turn left at the sign and the existing crematorium finger post at the junction for drivers approaching from the north is obscured by foliage.

- 3.2 Change the advanced warning sign so that the existing arrow is removed and replaced with the distance to the access road for vehicles travelling from the south.
- 3.3 Re-site the existing finger post to a more prominent position for vehicles travelling from the north.
- 3.4 Change the advanced warning sign so that the existing arrow is removed and replace with the distance to the access road for vehicles travelling from the north.

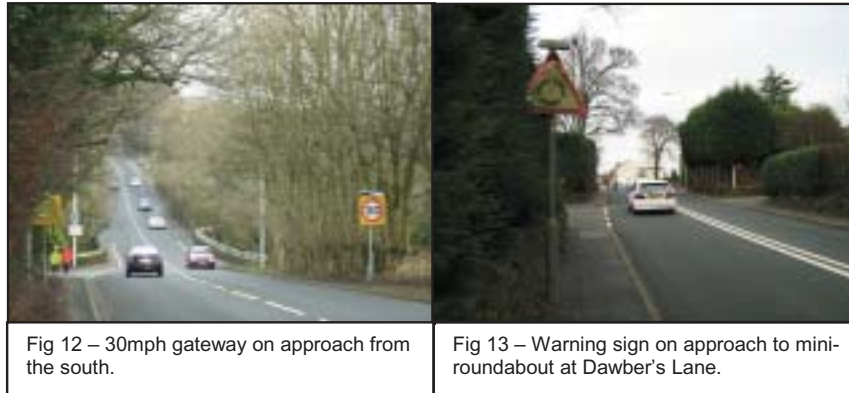
Fig 12 – 30mph gateway on approach from the south.

The existing 30mph gateway signing is obscured on approach from the south due to existing foliage.

The existing roundabout sign is difficult to distinguish on approach from the south due to its location and the current state of maintenance (See fig 13).

- 3.5 Back Lane requires resurfacing in the vicinity of the junction, this is a maintenance issue that needs to be addressed.
- 3.6 Investigate the possibility of moving the existing 30mph gateway to a more prominent position at the mouth of the bridge. Additionally place red 'textureflex' type surfacing across the width of the carriageway with a 30mph roundel facing northbound traffic and dragon's teeth markings on approach and change the existing 30mph signing to interactive signs with flashing amber lights.

- 3.7 Provide new roundabout signing on yellow backing board with additional distance to hazard plate underneath.

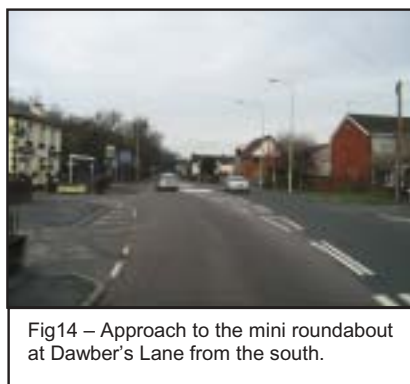
Fig14 – Approach to the mini roundabout at Dawber's Lane from the south.

The mini roundabout at Dawbers Lane is the location of several accidents. All involving vehicles travelling from the south, as such consideration should be given to remedial measures to improve the conspicuity of the mini roundabout to drivers.

- 3.8 Investigate the possibility of providing a small traffic island to the south of the mini-roundabout with additional roundabout signing in order to reinforce the location of the mini-roundabout.
- 3.9 Renew the existing mini-roundabout markings and white lining in the vicinity of the junction.
