ACCIDENT INVESTIGATION AND PREVENTION REPORT

**A49 – PRESTON ROAD
3.05KM – 6.15KM
CHARNOCK RICHARD**

3rd March 2008

ACCIDENT INVESTIGATION AND PREVENTION REPORT
A49, PRESTON ROAD, 3.05KM – 6.15KM, CHARNOCK RICHARD

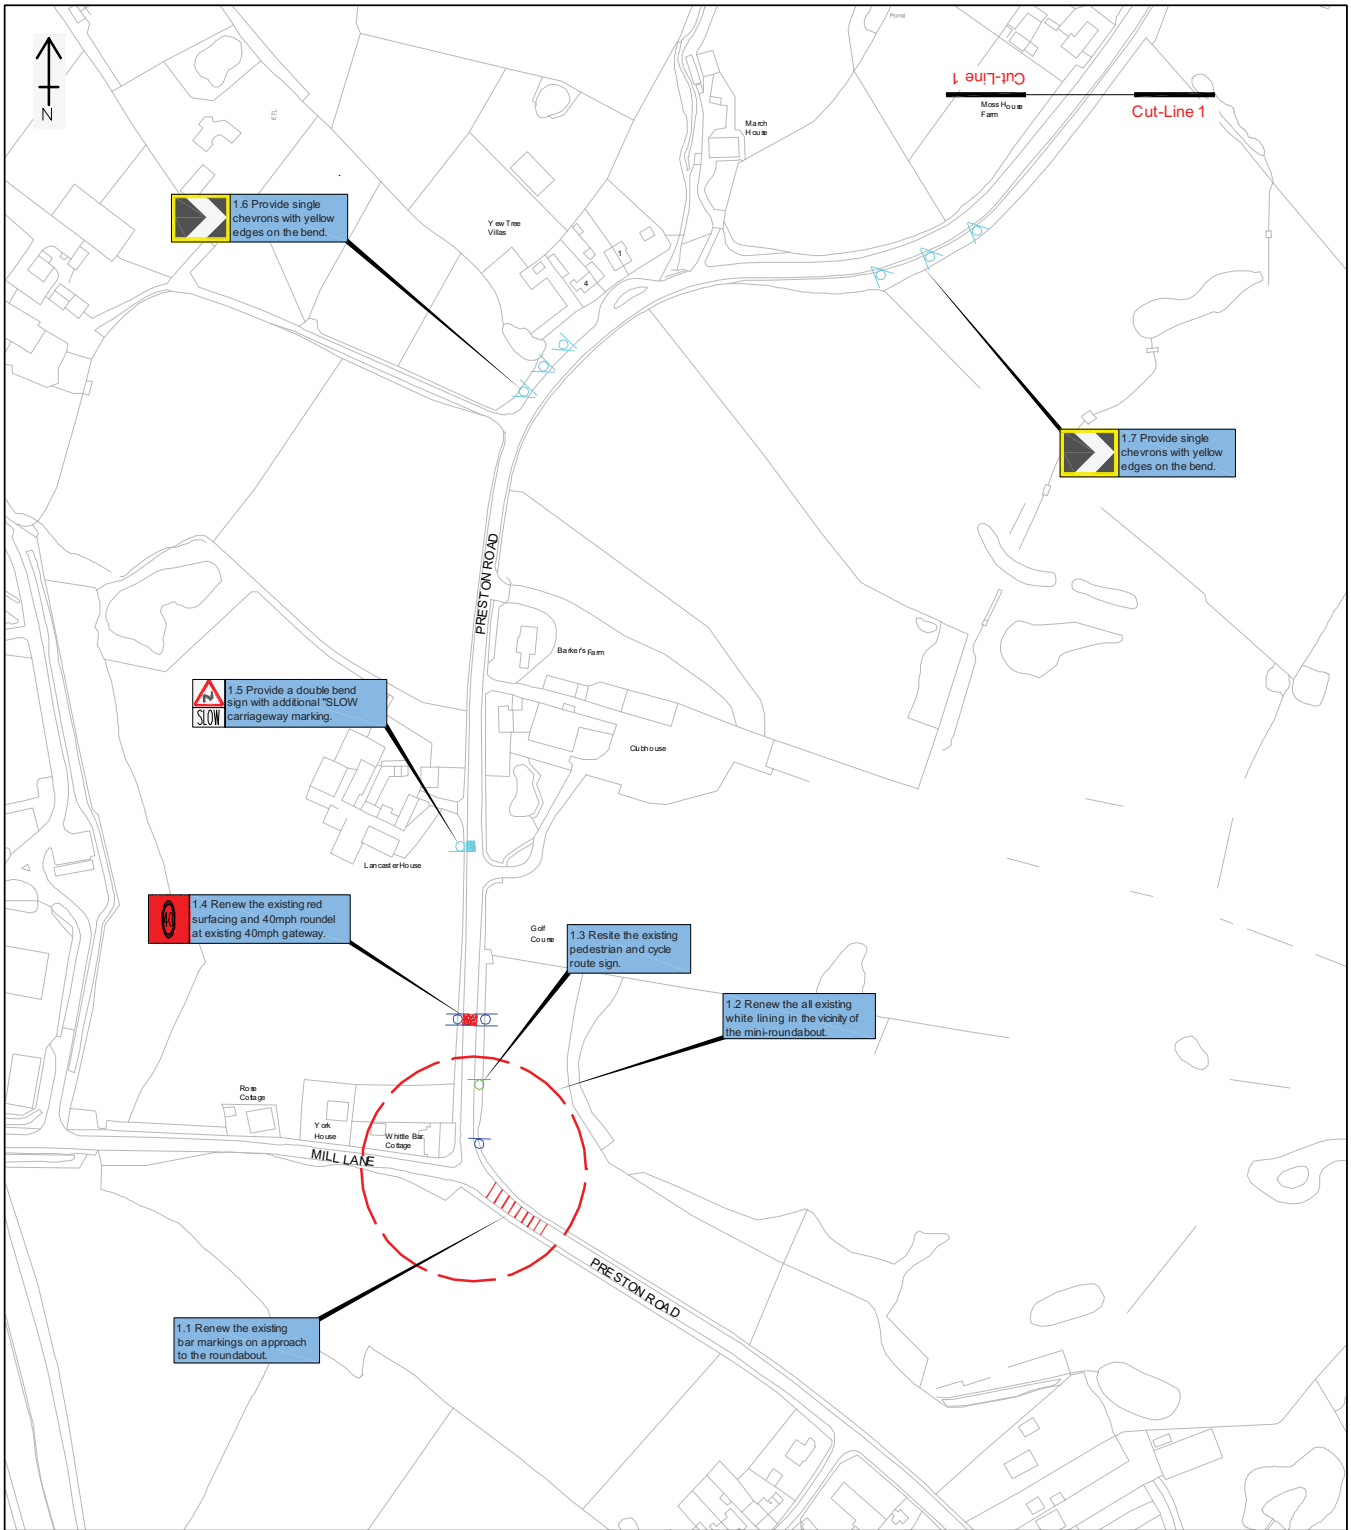
- 1.1 The existing bar markings are worn and faded. Renew existing bar marking to the south of the junction.

- 1.2 The existing white lining and markings on and around the roundabout are worn. Renew the existing white lining at the junction, in particular the give way markings and mini-roundabout markings. This will improve the conspicuity of the mini-roundabout for drivers.
- 1.3 The mini-roundabout sign on the approach to the roundabout from the north is hard to distinguish from other street furniture. Re-site the existing pedestrian and cycle route sign (see fig 4) to improve visibility.

The existing 40mph gateway (see fig 4) is becoming worn and as a result its impact is reduced.

- 1.9 Provide a new crossroads sign and mount on grey backing board with the existing bend in road sign mounted below for traffic approaching from the south.

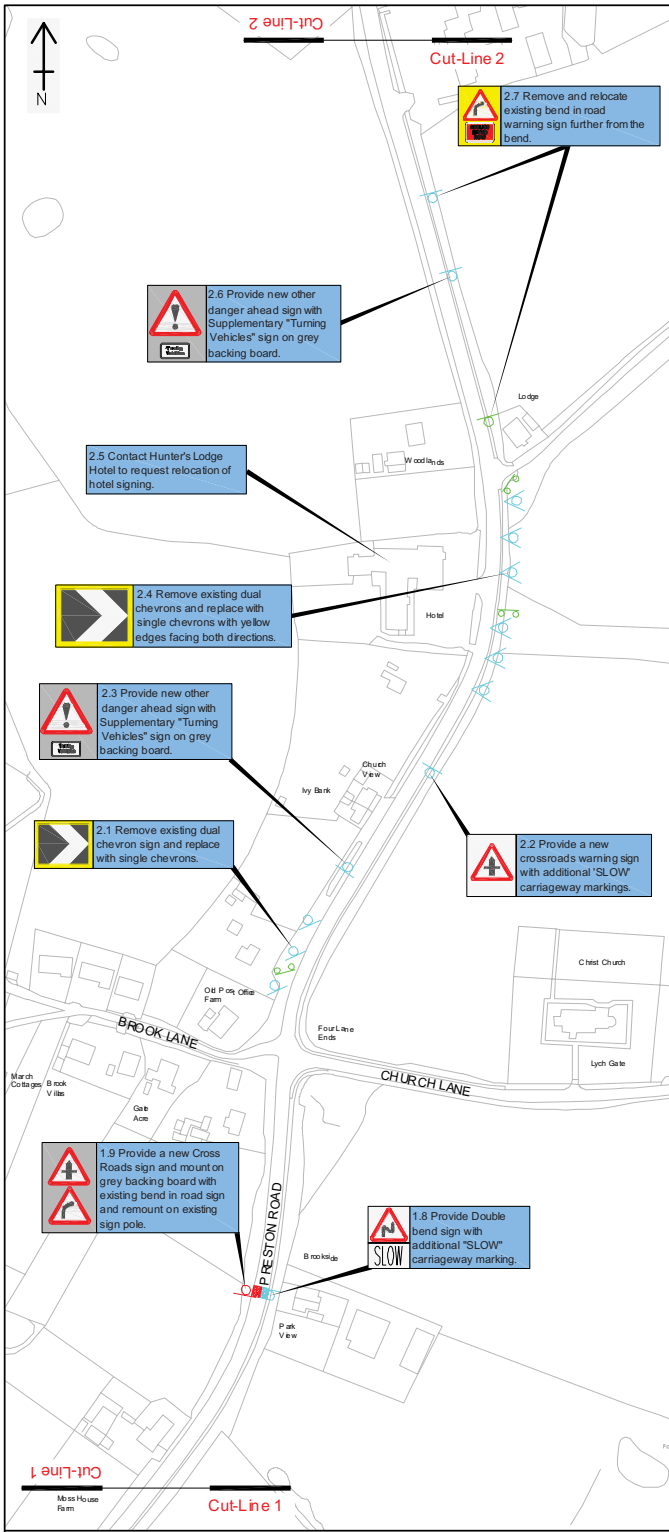
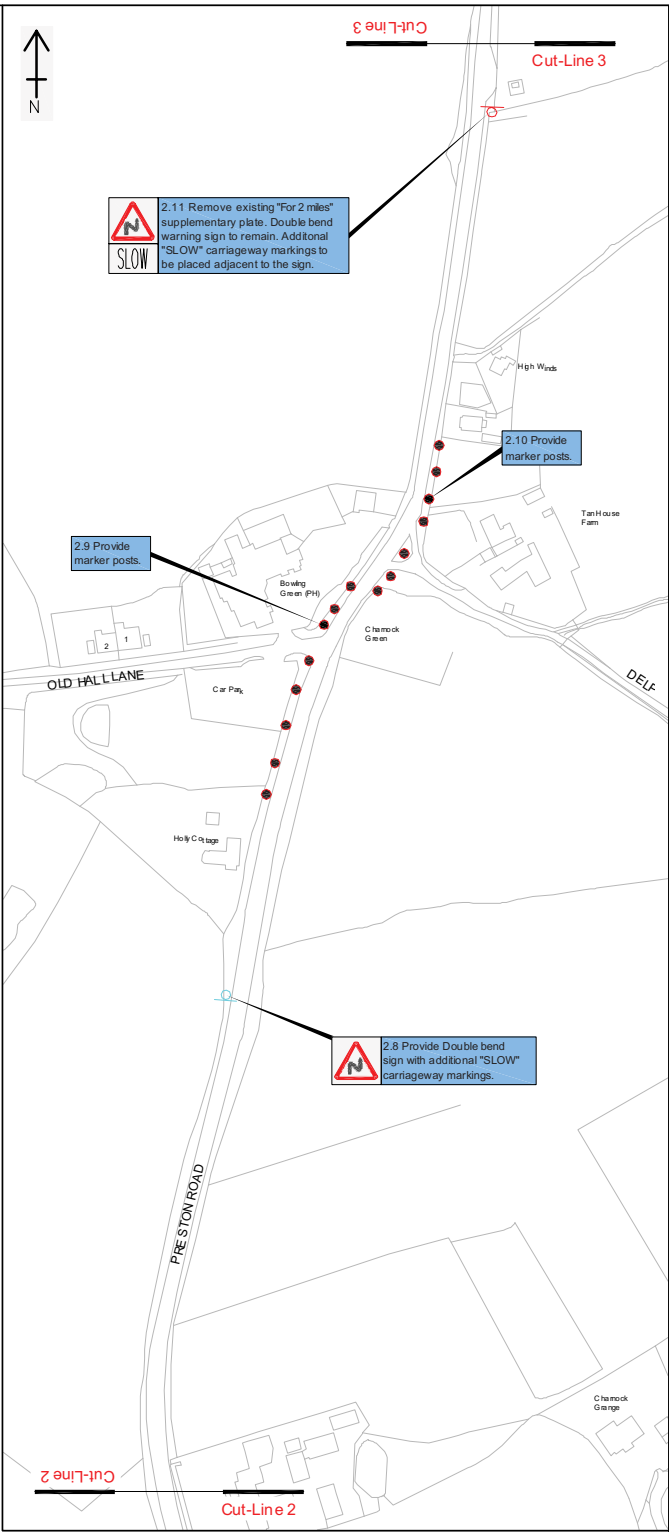
The double bend adjacent to the Old Hall Lane and Delph Lane side roads is the location of three accidents, all of which are the result of vehicle failing to negotiate the bends. There are currently no warning signs to alert drivers of the road layout for vehicles travelling from the south. To the north of the double bends there is an existing double bend sign with a supplementary “for a distance of 2 miles” plate below. The sign although providing some warning to drivers does not specifically highlight the upcoming double bend.

- 2.1 For continuity of the scheme the existing double chevron sign should be replaced with single chevrons with yellow edging.

- 2.3 Provide a new other danger ahead sign with supplementary "Turning Vehicles" sign on grey backing board with "SLOW" carriageway markings adjacent to the sign on approach to the hotel entrance from the south.
- 2.4 Remove existing double chevron signs and replace with two sets of three dual-sided single chevrons signs with yellow edges to alert drivers to the road layout when travelling from both the north and south.
- 2.5 Contact the Hunter's Lodge Hotel and request that existing signing located near the carpark entrance be relocated in order to improve sightlines for drivers exiting the carpark.
